September 12, 2008

Cal OSHA Document Request Regarding TEL Facility Investigation

INSPECTION RECOMMENDATION

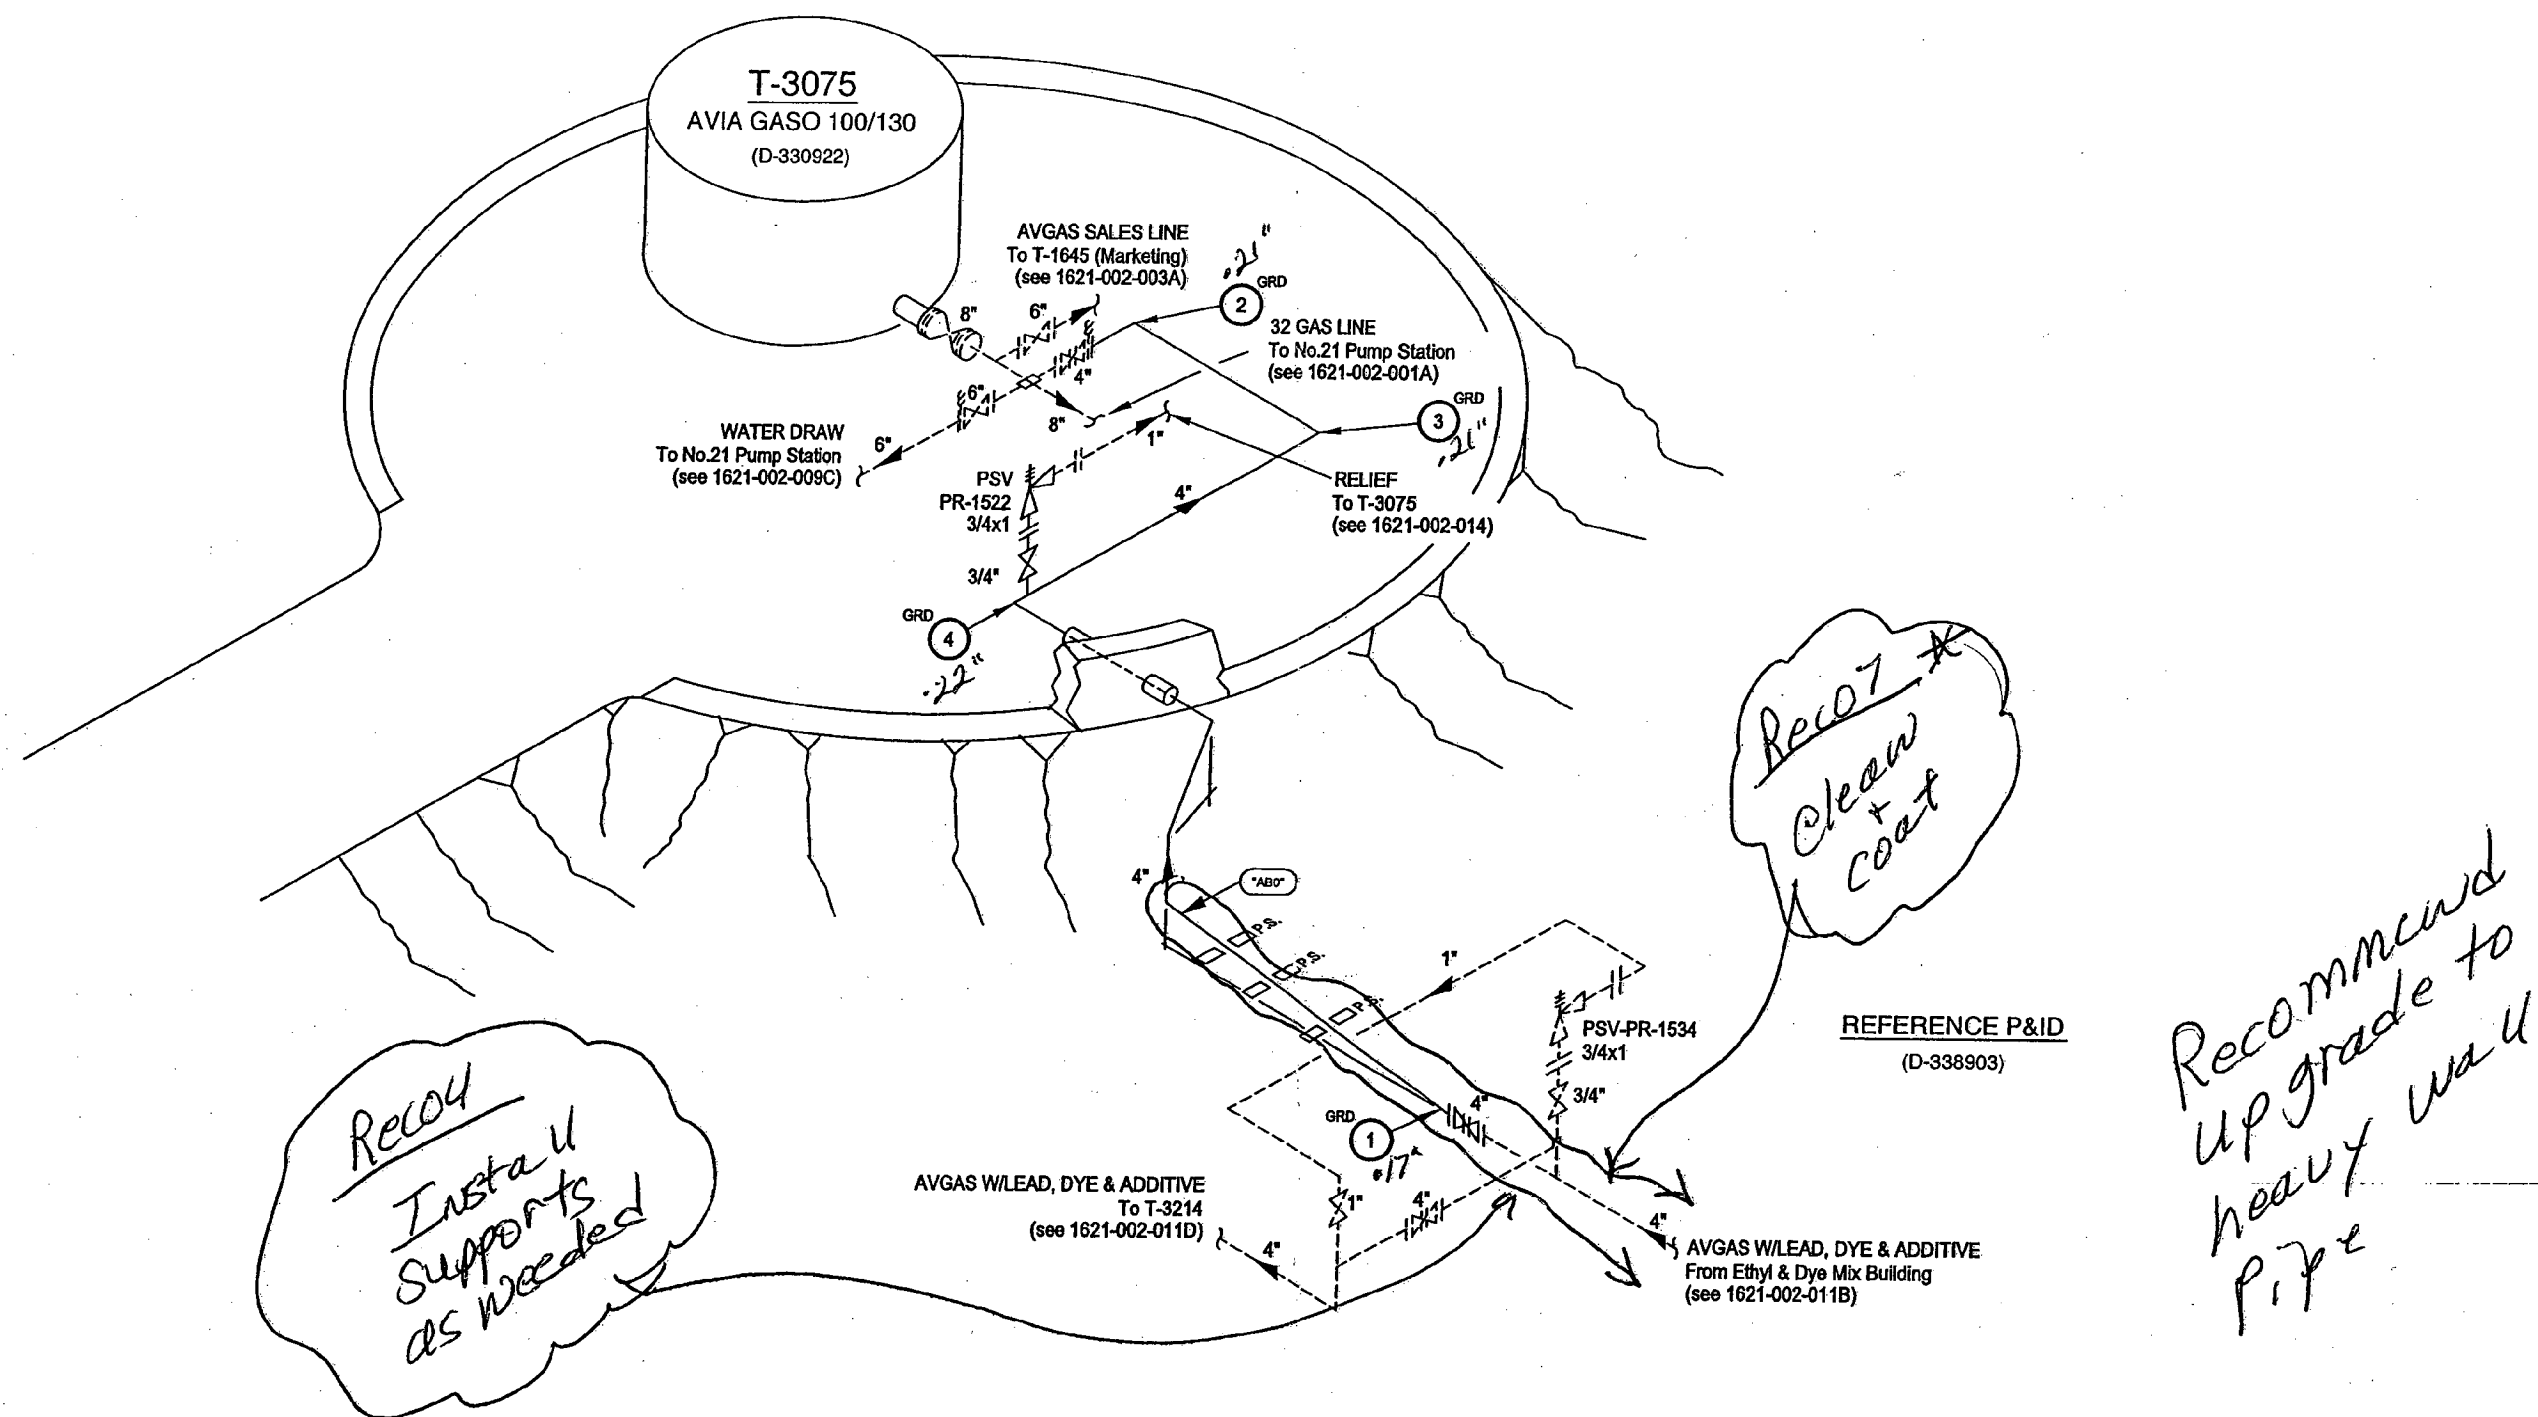
STATUS: ISO570 COMPLETE		RATING? <input type="checkbox"/> 150# <input checked="" type="checkbox"/> 300#		API-570 <input type="checkbox"/> CLASS I		9/14/05 mhee	INSPECTION PIPING ISOMETRIC			
MATERIAL: C.S.		SERVICE: AVGAS		<input type="checkbox"/> CLASS II			#2 AVGAS / TOLUENE			
PIPE CLASS: "AF1"		PWHT: NO		<input type="checkbox"/> CLASS III			LOWER MAIN TANK FIELD			
LINE NAME: No.1 LEAD LINE							BLENDING AND SHIPPING AREA BUSINESS UNIT			
FROM: ETHYL & DYE MIX BUILDINGS						Z	1621-002-011A		REV	SHT
TO: VICINITY OF STANDARD & T-922										
								3	1

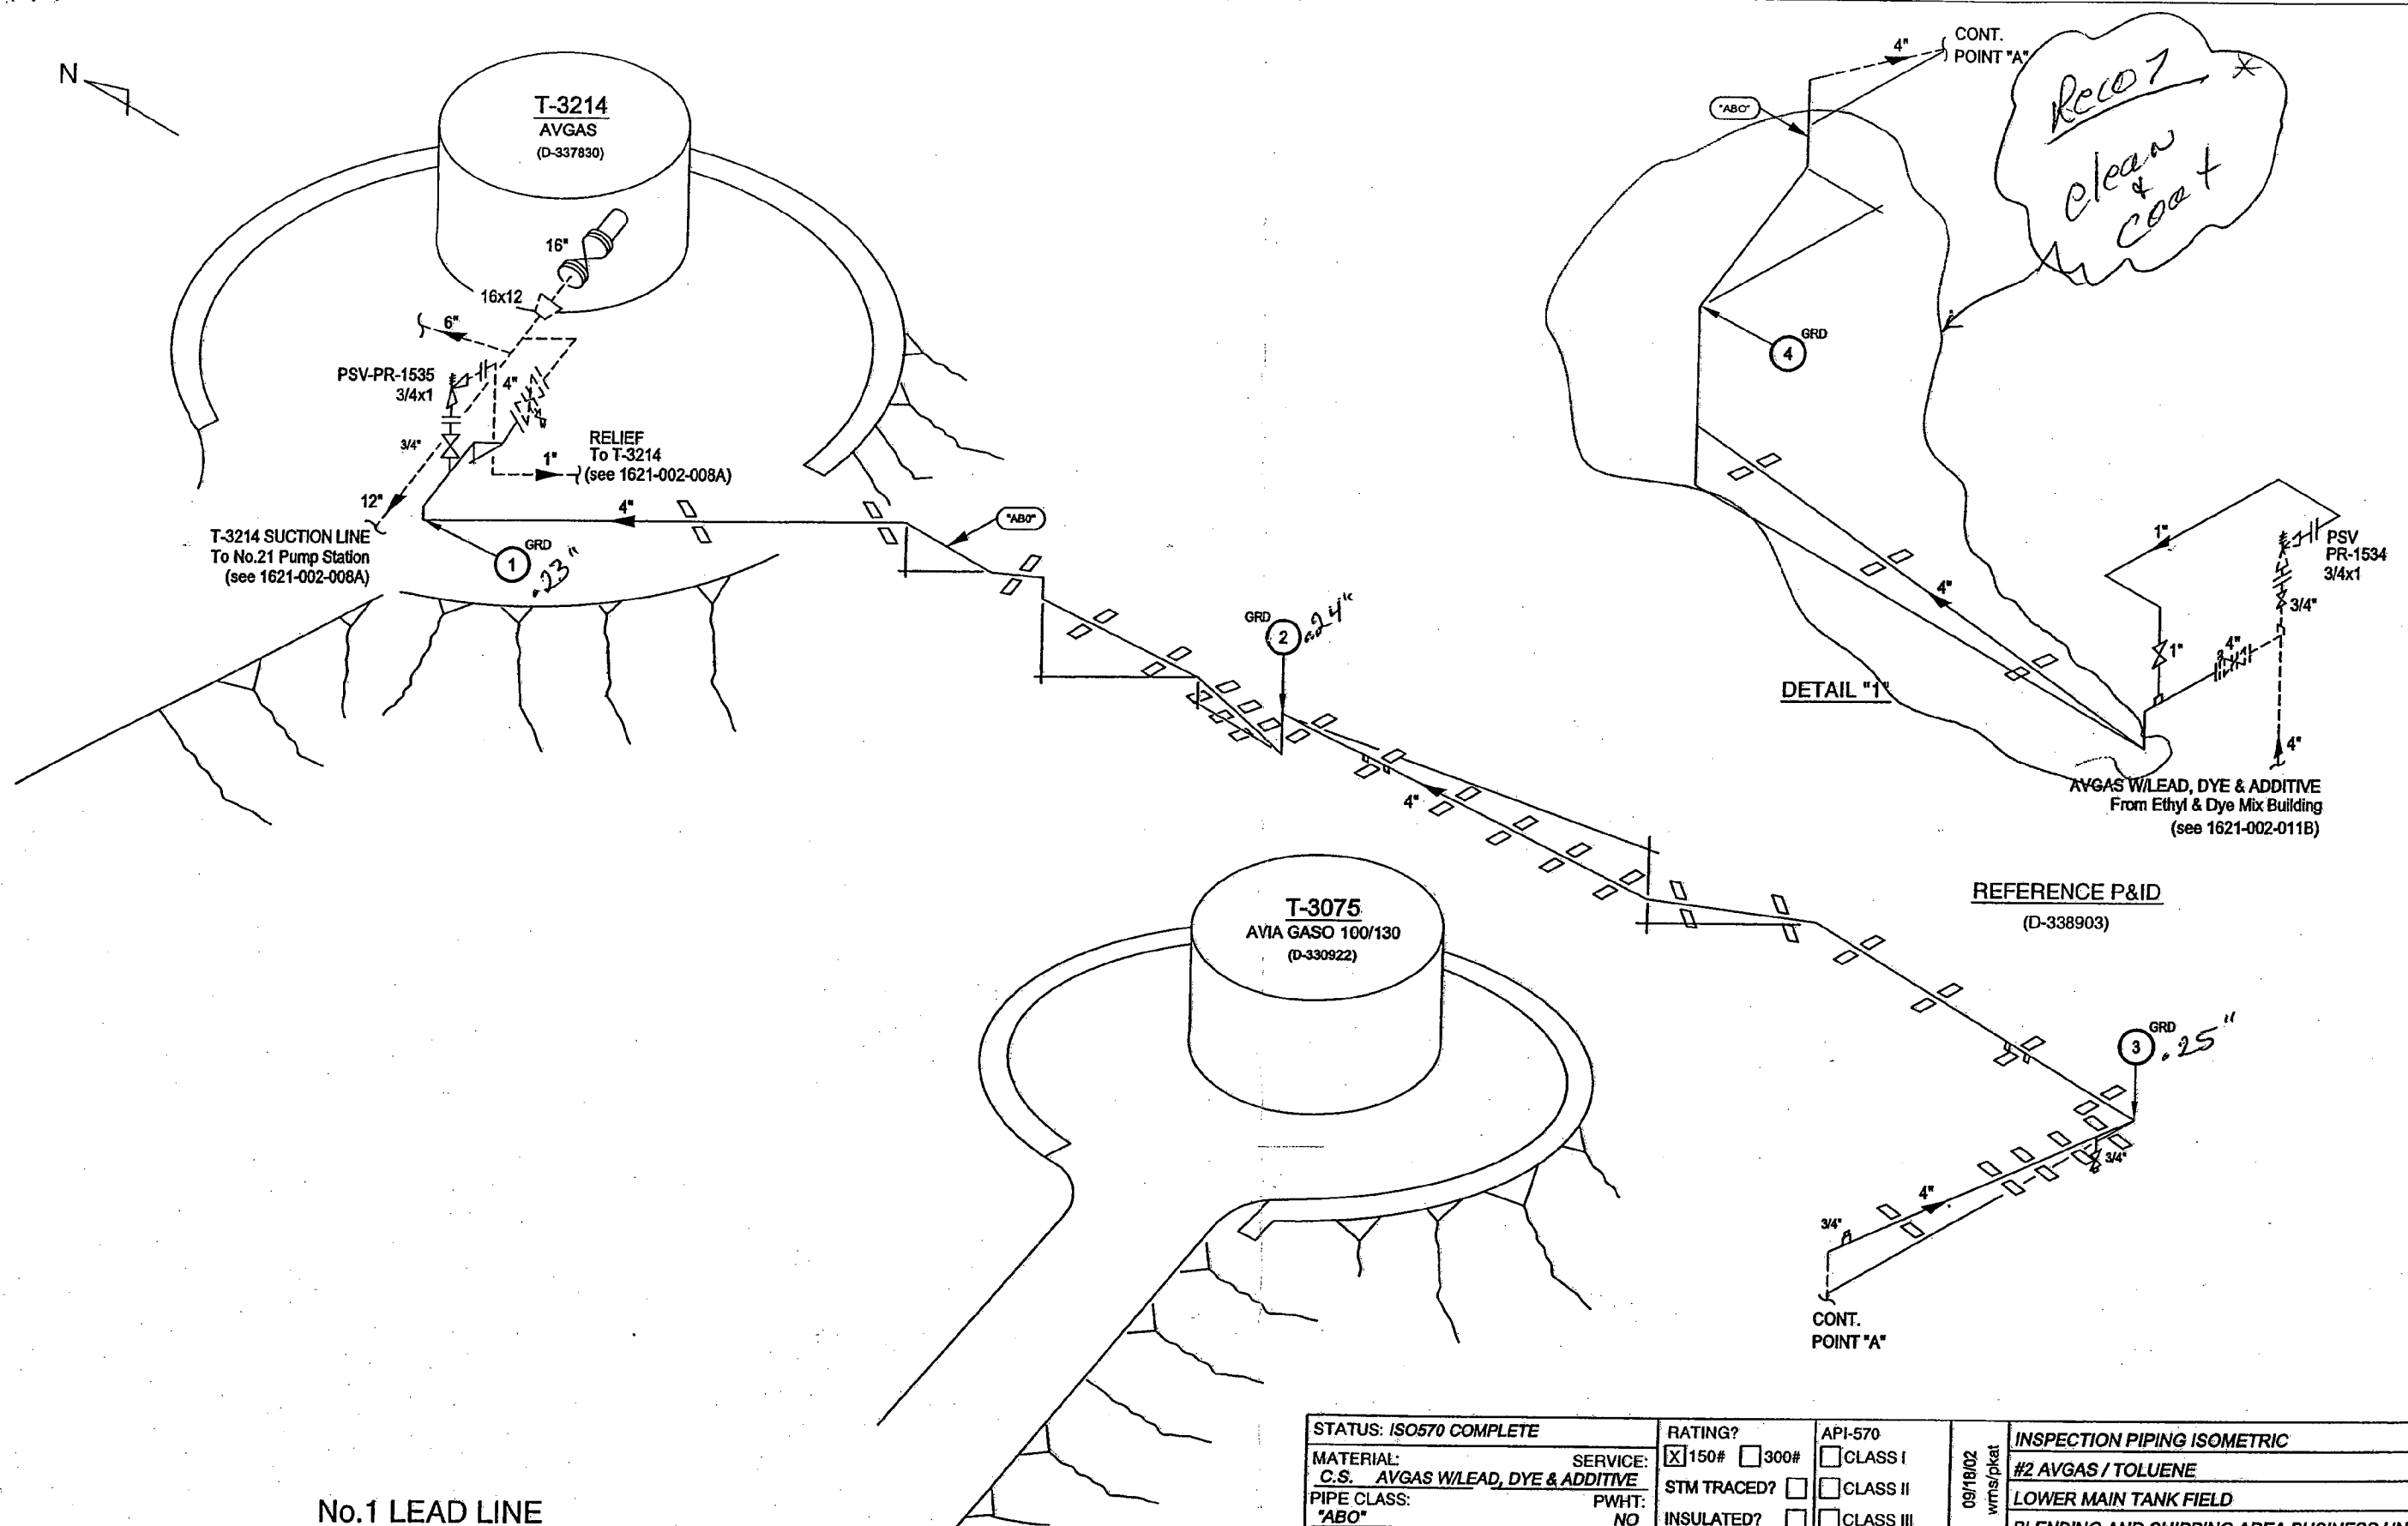
No.1 LEAD LINE

STATUS: <u>ISO570 COMPLETE</u>		RATING?		API-570	08/18/02 wrns/pkwt	INSPECTION PIPING ISOMETRIC	
MATERIAL: <u>C.S. AVGAS W/LEAD, DYE & ADDITIVE</u>		<input checked="" type="checkbox"/> 150# <input type="checkbox"/> 300#		<input type="checkbox"/> CLASS I		#2 AVGAS / TOLUENE	
PIPE CLASS: <u>ABO</u>		STM TRACED? <input type="checkbox"/>		<input type="checkbox"/> CLASS II		LOWER MAIN TANK FIELD	
PWHT: <u>NO</u>		INSULATED? <input type="checkbox"/>		<input type="checkbox"/> CLASS III		BLENDING AND SHIPPING AREA BUSINESS UNIT	
LINE NAME: <u>No.1 LEAD LINE</u>					Z	1621-002-011C	
FROM: <u>SLEEPERWAY BELOW T-3075</u>							
TO: <u>T-3075</u>							
						REV	SH
						1	1

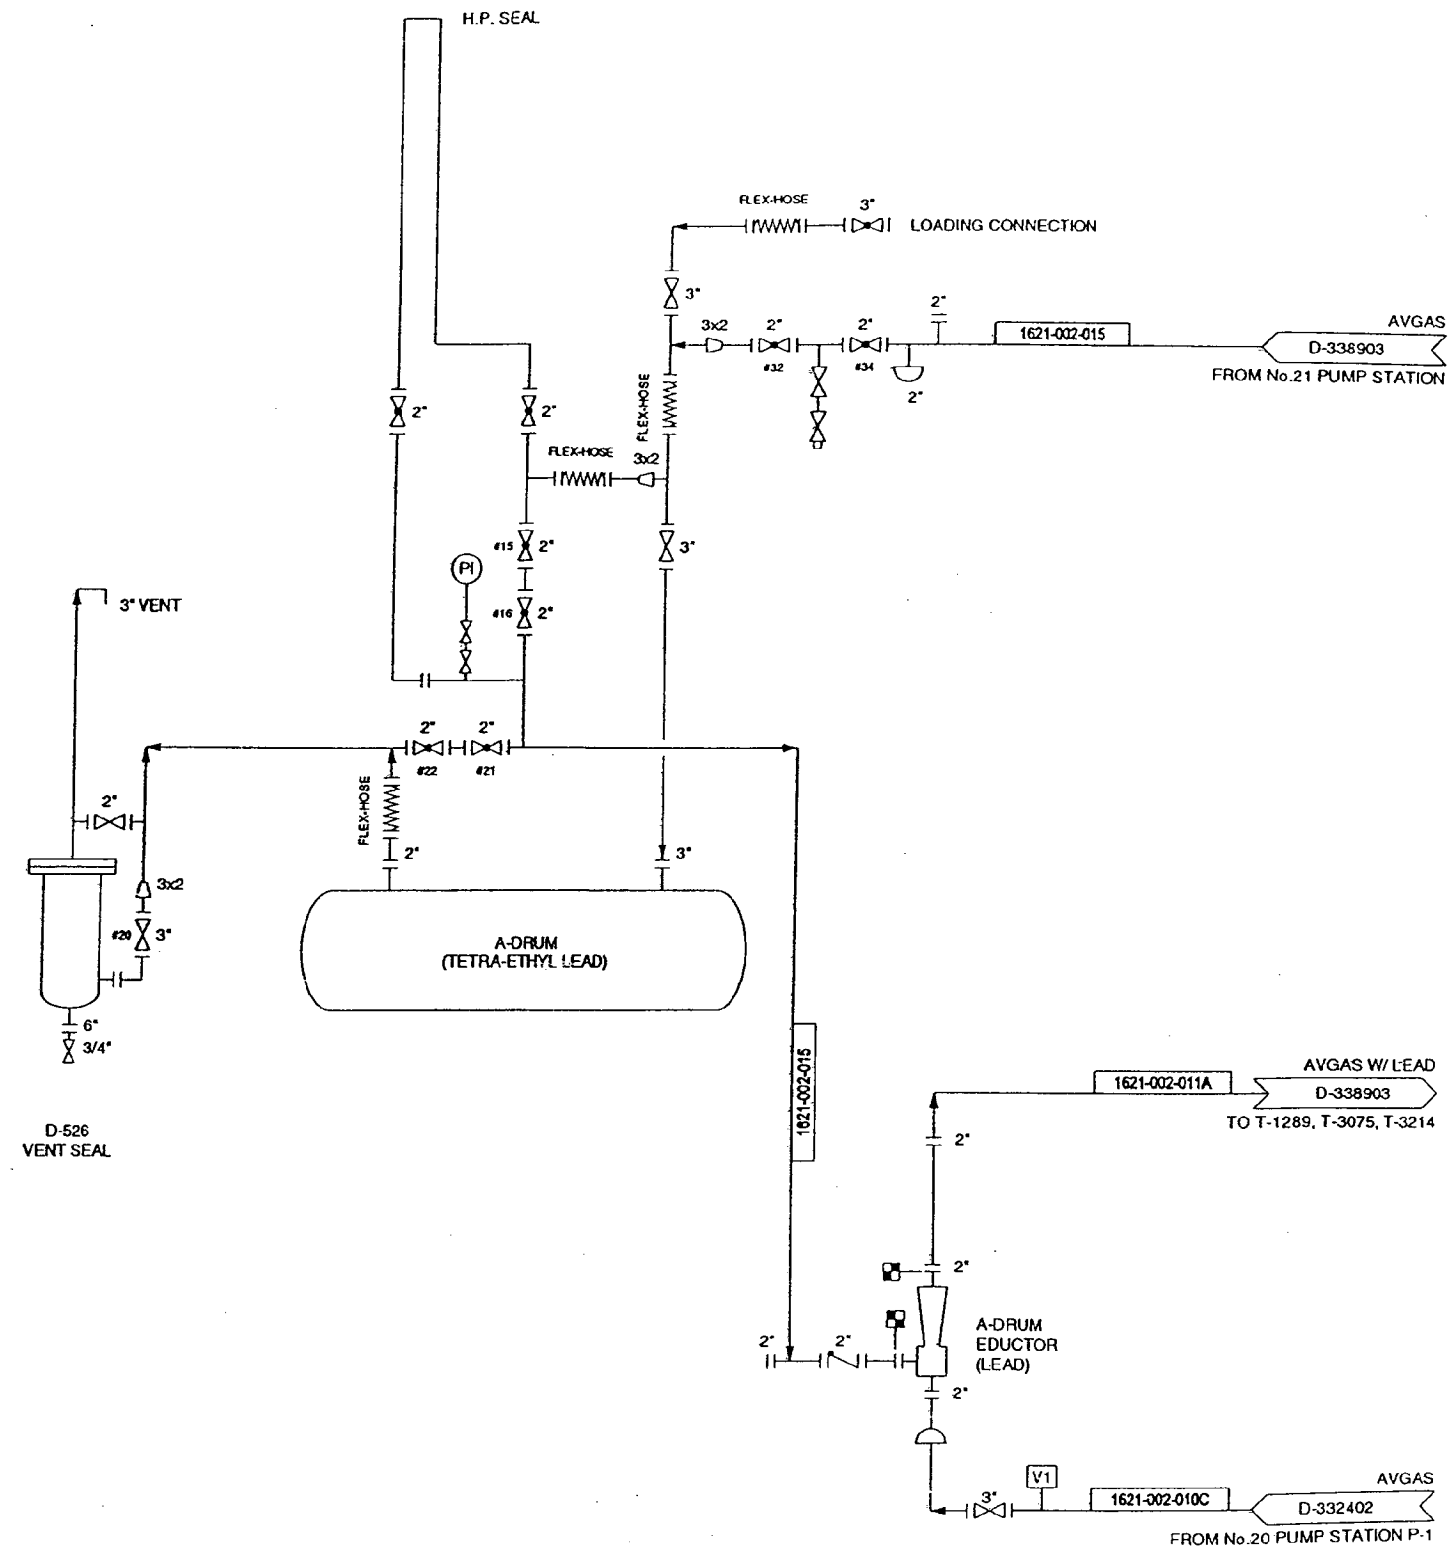
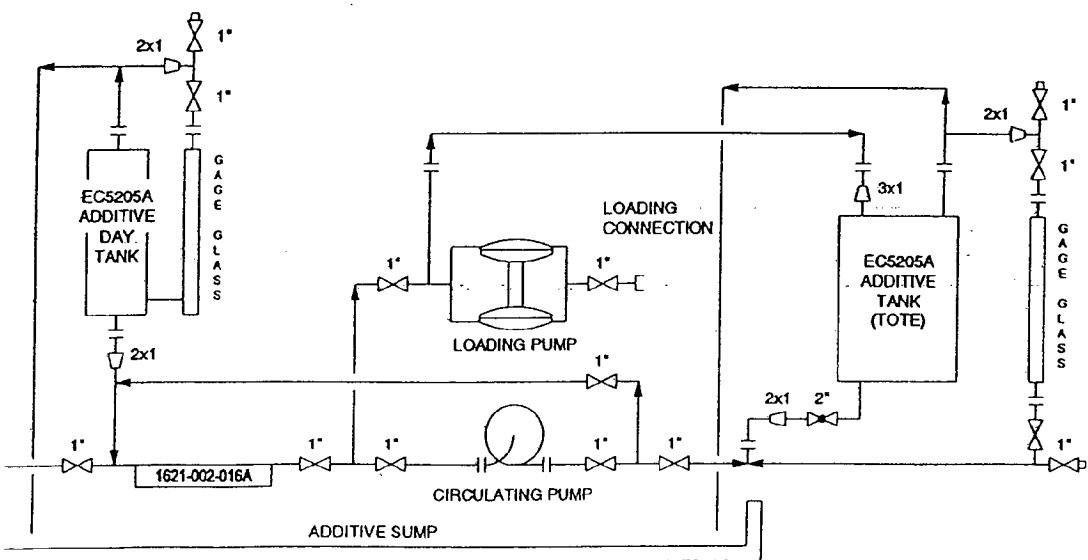
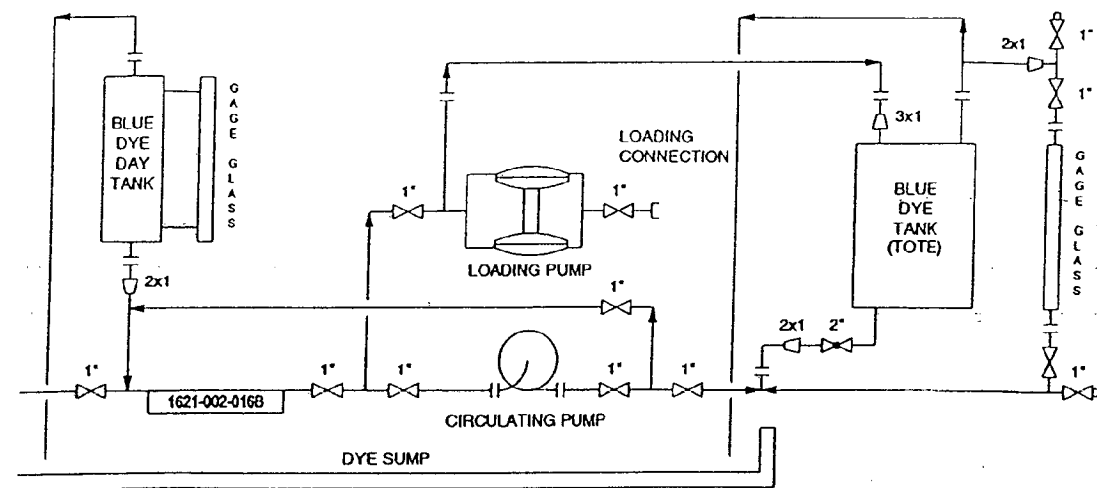
12/17/04 mhee	INSPECTION PIPING ISOMETRIC			
	#2 AVGAS / TOLUENE			
	LOWER MAIN TANK FIELD			
	BLENDING AND SHIPPING AREA BUSINESS UNIT			
Z	1621-002-015	4)b.	REV	SHT
			4	1

NOTE:
Piping Class shown on this
dwg is for replacement ONLY
exist. class is UNKNOWN

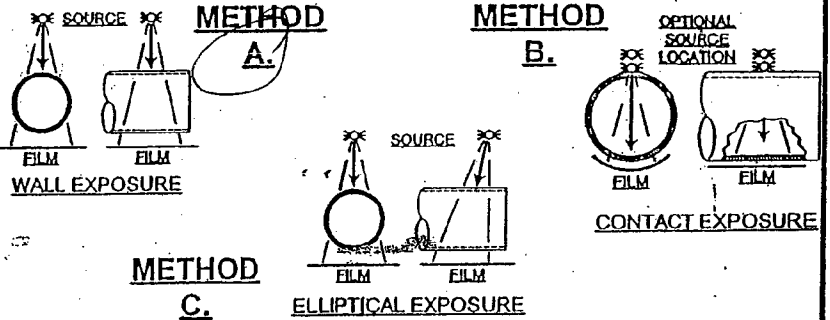
EXPOSURE SKETCH OR ADDITIONAL INFORMATION

COMMENTS: 0° WAS SHOT FROM SOUTH TO NORTH
90° WAS SHOT FROM EAST TO WEST

NOTE: NOZ # 2 90° WAS SHOT FROM WEST TO EAST
